# Trail Road Battery Energy Storage System (BESS) Fluvial Geomorphology Assessment

H375035-0000-2B0-066-0001

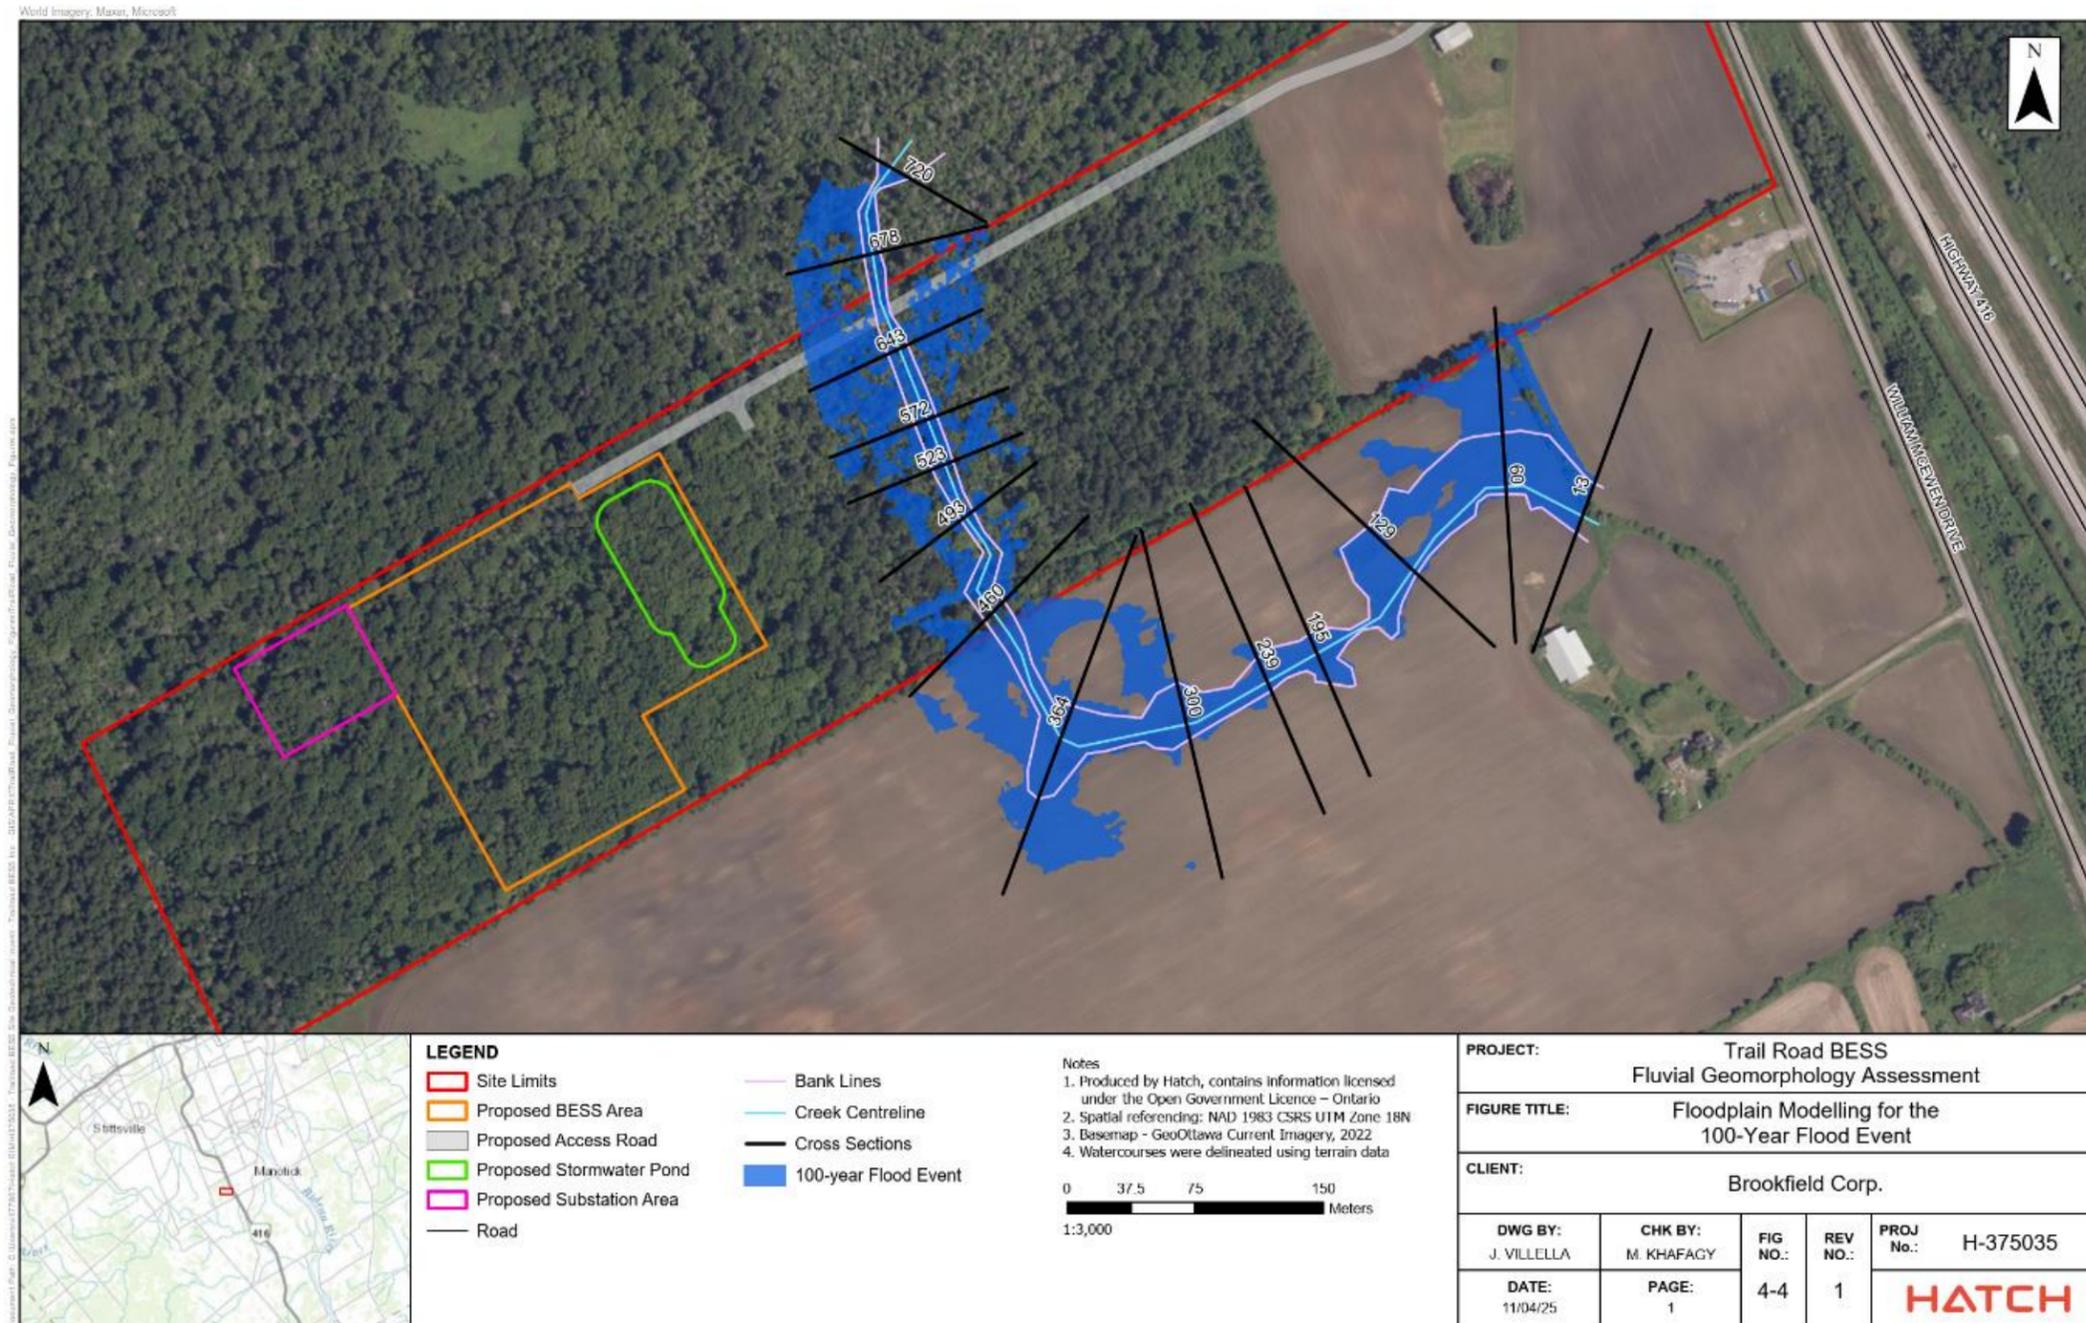
Figure 4-4: Results of Trail Road Creek Floodplain) Modelling for the 100-year Flood Event

The results of the 100-year flood events at the Creek are shown in Figure 4-4 below.

- HEC-RAS 1D hydraulic modelling was performed to estimate floodplain extents under various design flow scenarios. The 100-year floodplain delineation supported the erosion hazard assessment and confirmed no encroachment into the proposed development footprint.

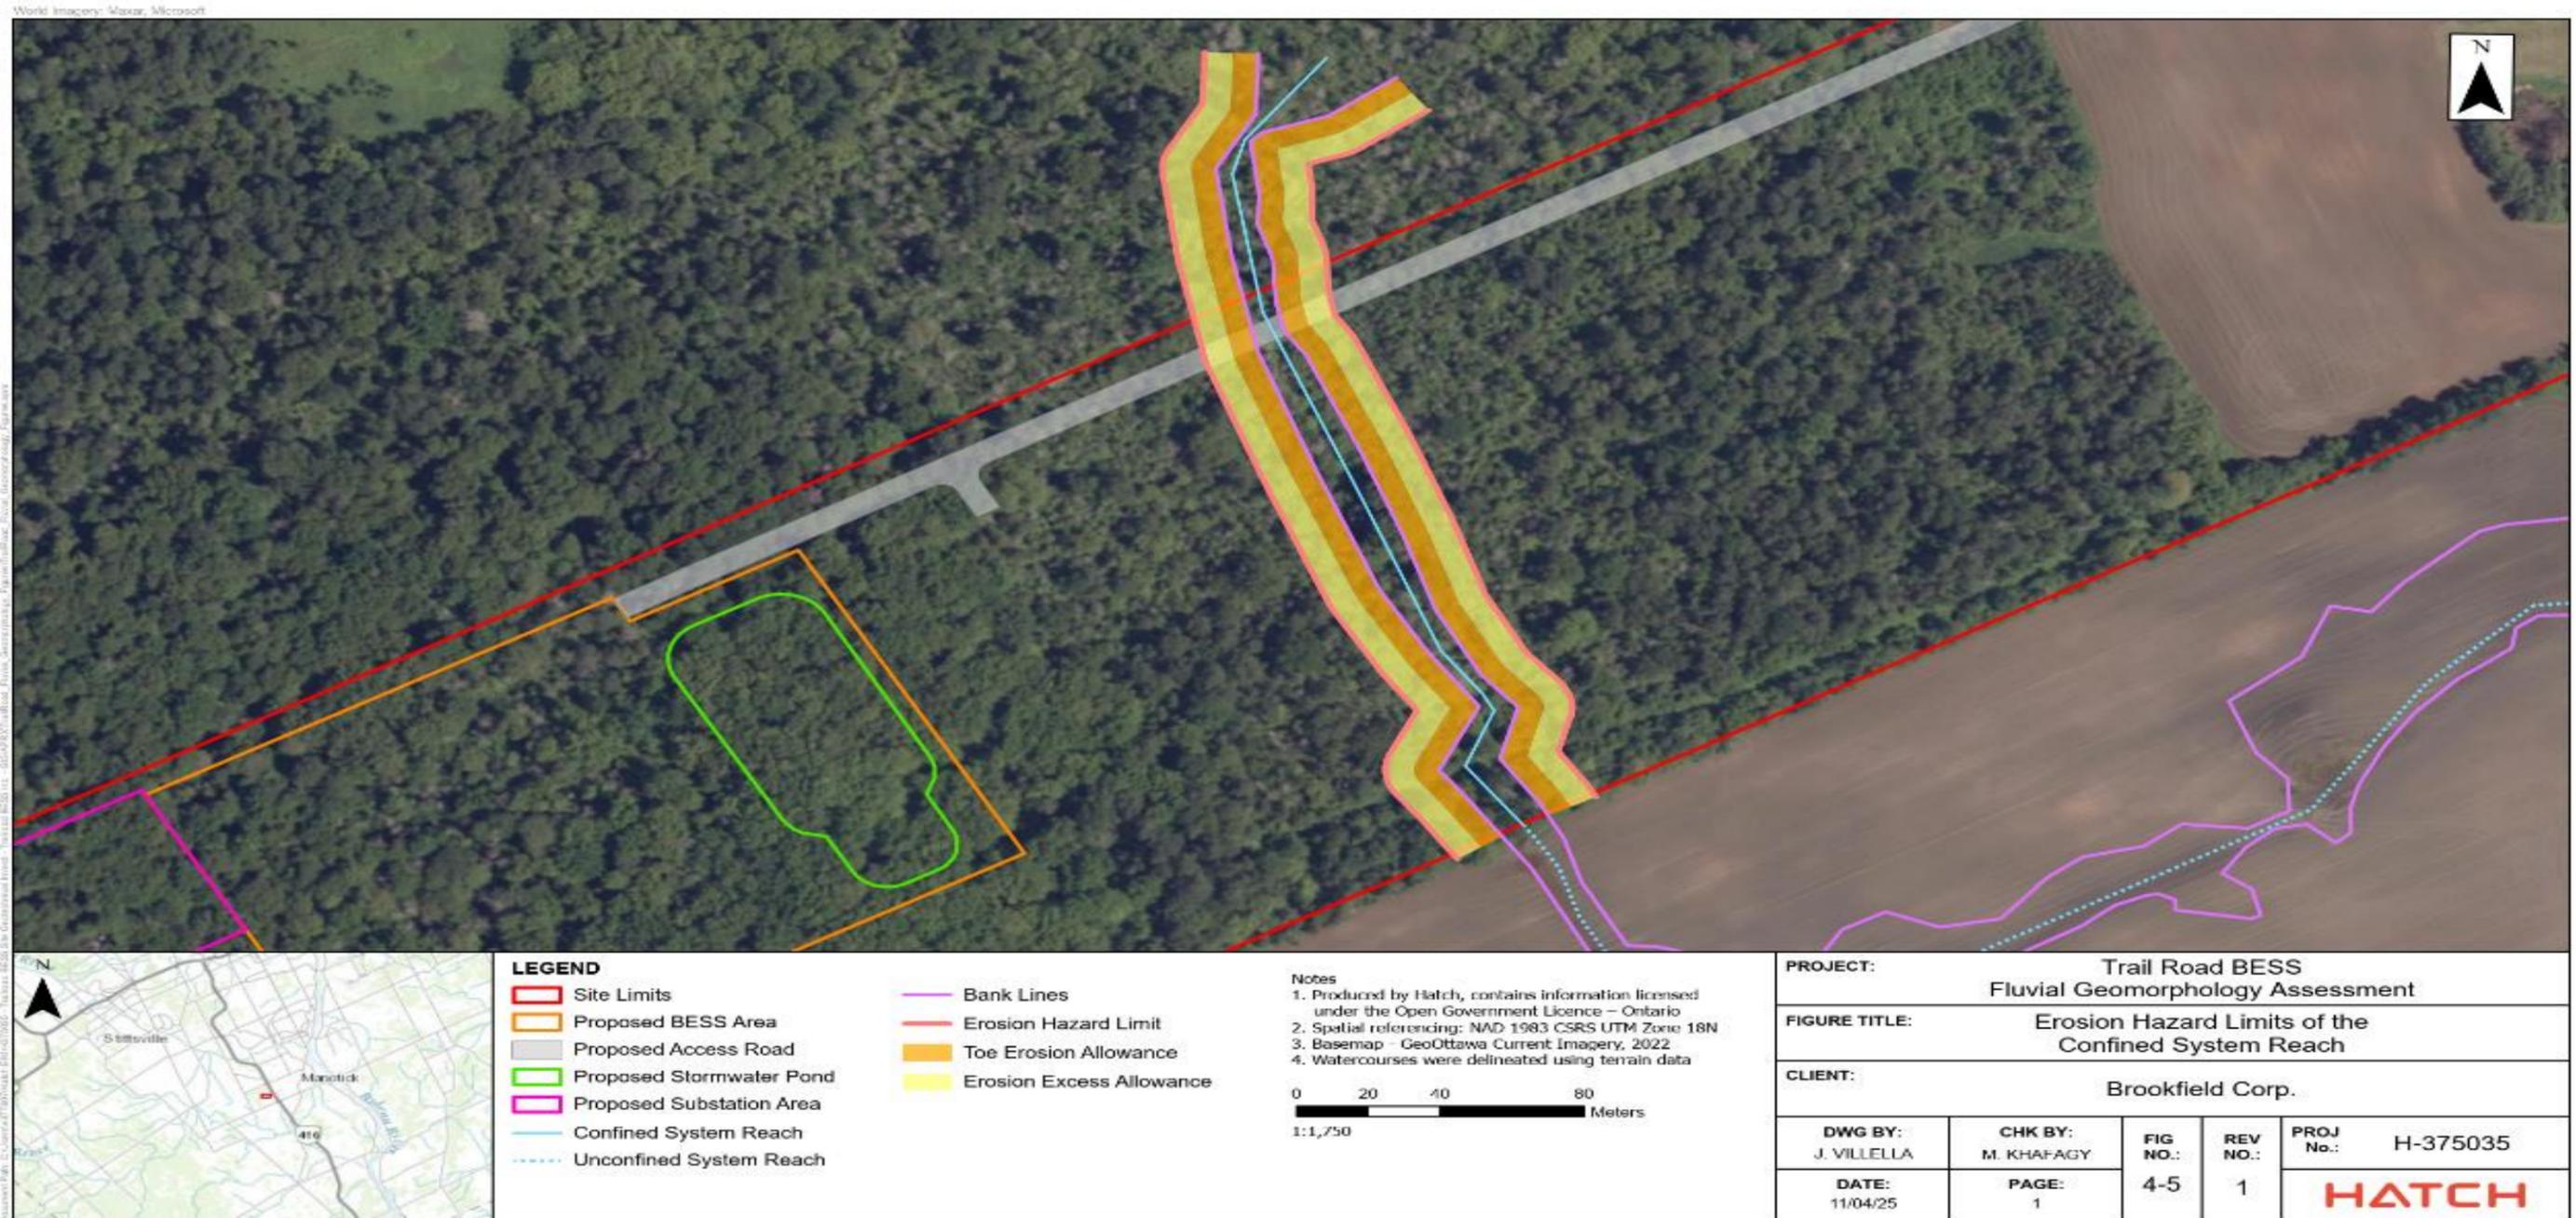
Figure 4-5: Erosion Hazard Limit of the Confined System Reach

Therefore, a stable slope allowance is not considered necessary for this reach of the watercourse. Erosion Access Allowance is a minimum access distance is typically applied at the top of the valley slope to allow space for maintenance or future stabilization works. Regarding the erosion access allowance, MNR Technical Guide (2002) guidelines note that for stiff/hard cohesive soil (clays, clay silt) and coarse granular (gravels) tills, a 5 to 8 m erosion access is to be applied. Given the evidence of erosion along the Creek, erosion access allowance of 8 m is recommended.

The proposed development area is located entirely outside the delineated erosion hazard limit associated with the confined system reach of the Creek. As shown in Figure 4-5, there is no overlap between the development footprint and the defined erosion hazard components, including the toe erosion allowance and erosion access allowance. Some considerations should be applied for the proposed service road crossing the Creek and discussed in Section 4.6. This confirms that the development, as currently planned, does not encroach upon areas identified as geomorphologically sensitive or at risk of fluvial erosion.

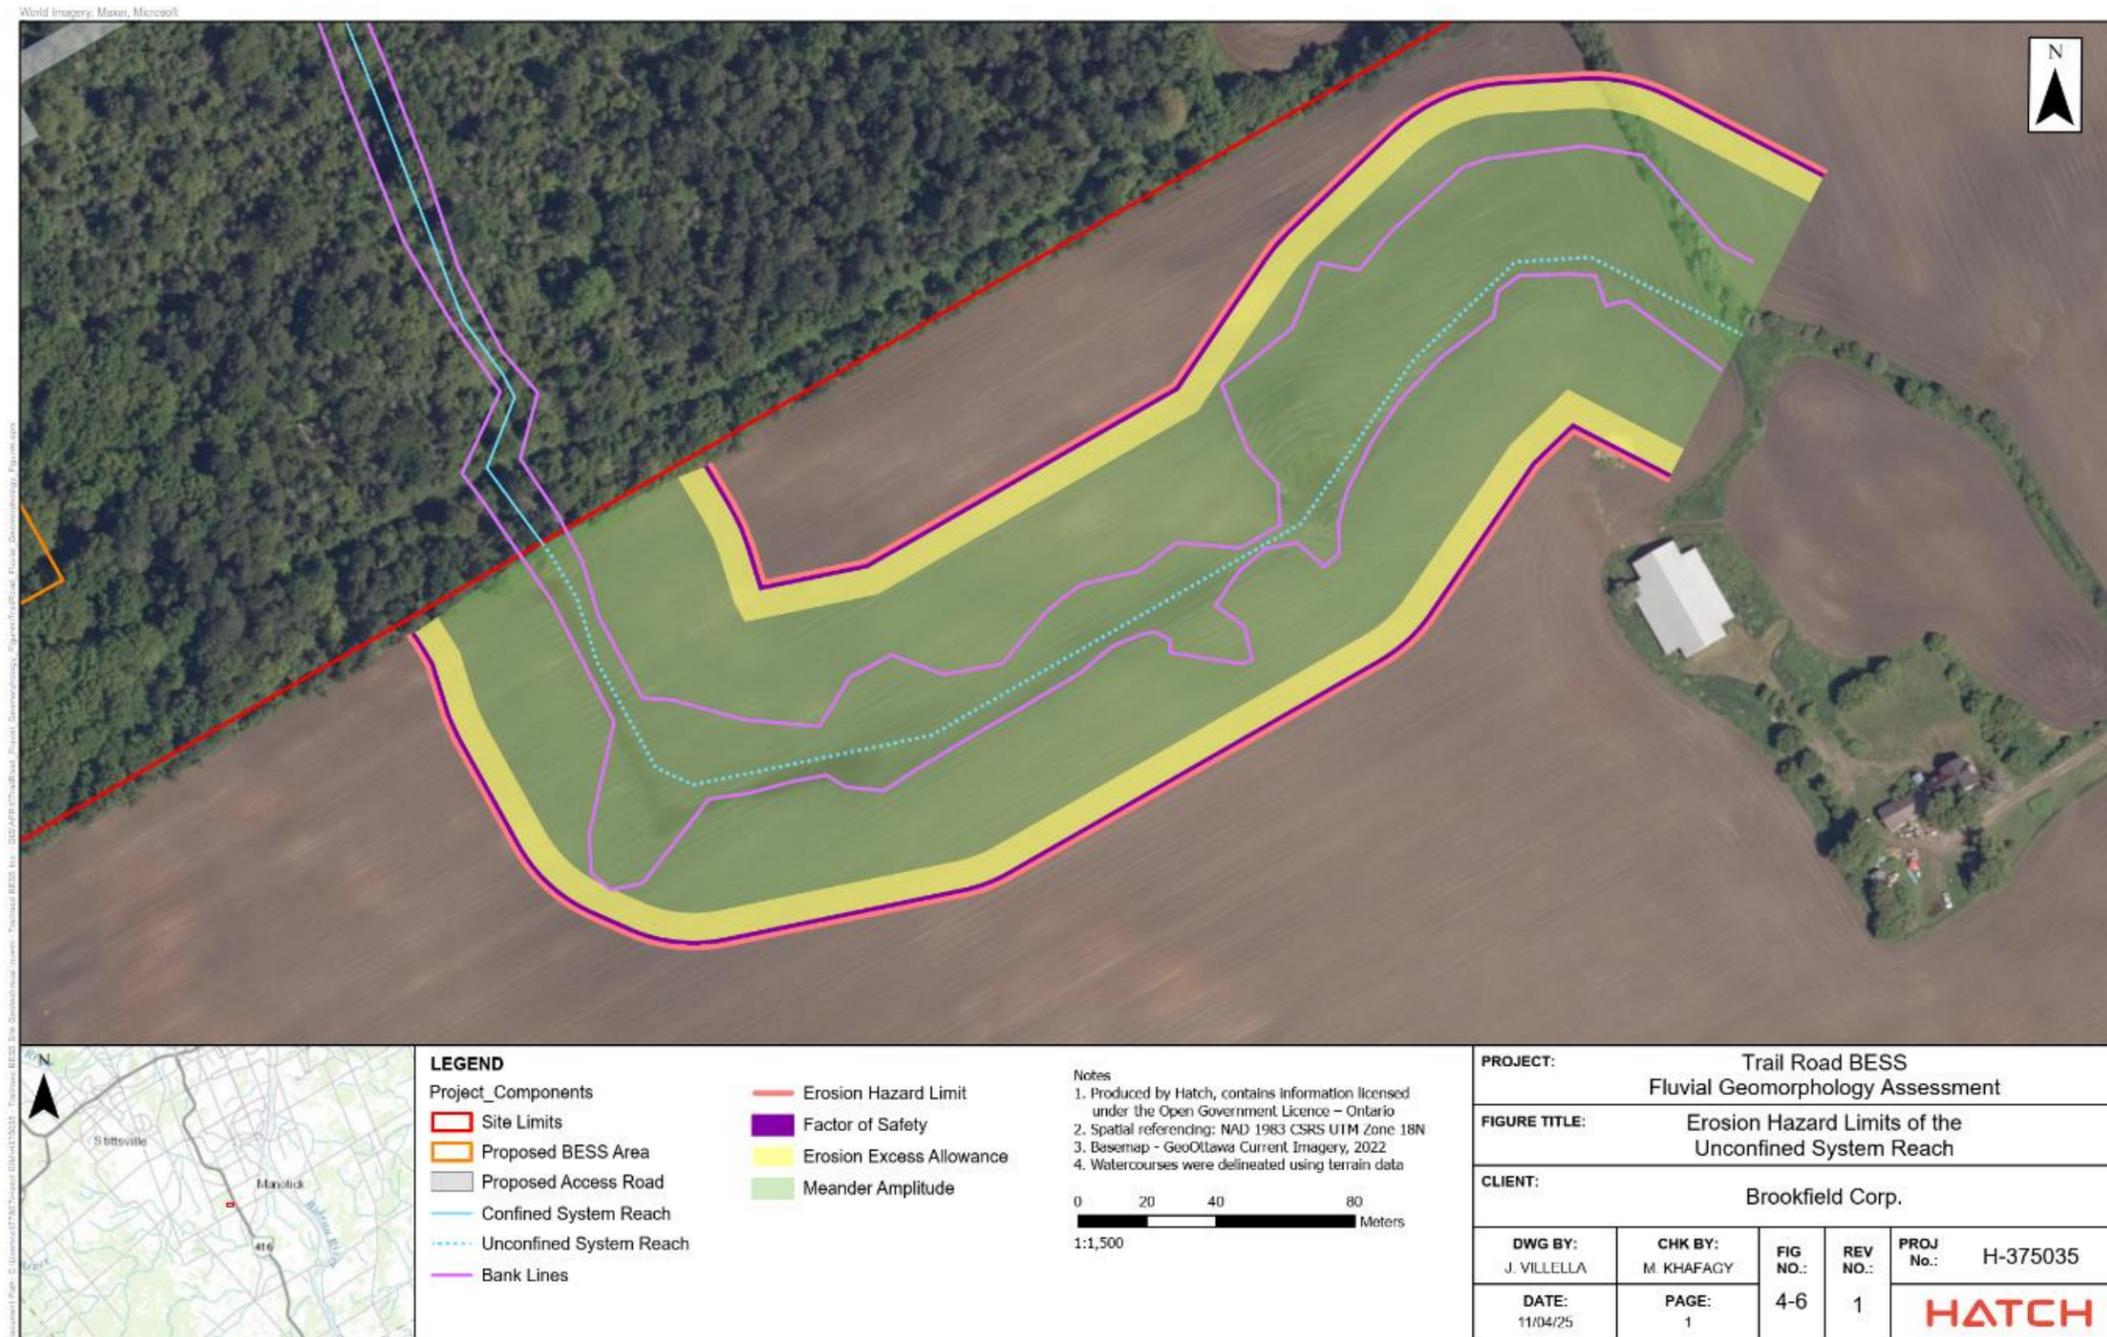
Figure 4-6: Erosion Hazard Limit of the Unconfined System Reach

The downstream reach of the Creek transitions into an unconfined system. In such systems, the erosion hazard is better assessed using a meander belt width approach, which reflects the maximum fixed lateral extent of historical and potential future channel migration. As per MNR Technical Guide (2002), the meander belt width is defined as the summation of meander amplitude and erosion access allowance. In this case, the historical aerial photograph analysis confirms lateral channel migration and expansion of the channel and adjacent wetland features over time. An erosion access allowance of 8 m is recommended for the unconfined system reach. Figure 4-6 shows the erosion hazard limit for both reaches of the Creek (Unconfined System) including the Meander belt Width and erosion access allowance.

An appropriate safety factor can be applied to the Erosion Hazard limit as per guideline recommendations. A 2 m safety factor has been applied to both reaches of the creek (the confined and unconfined systems).

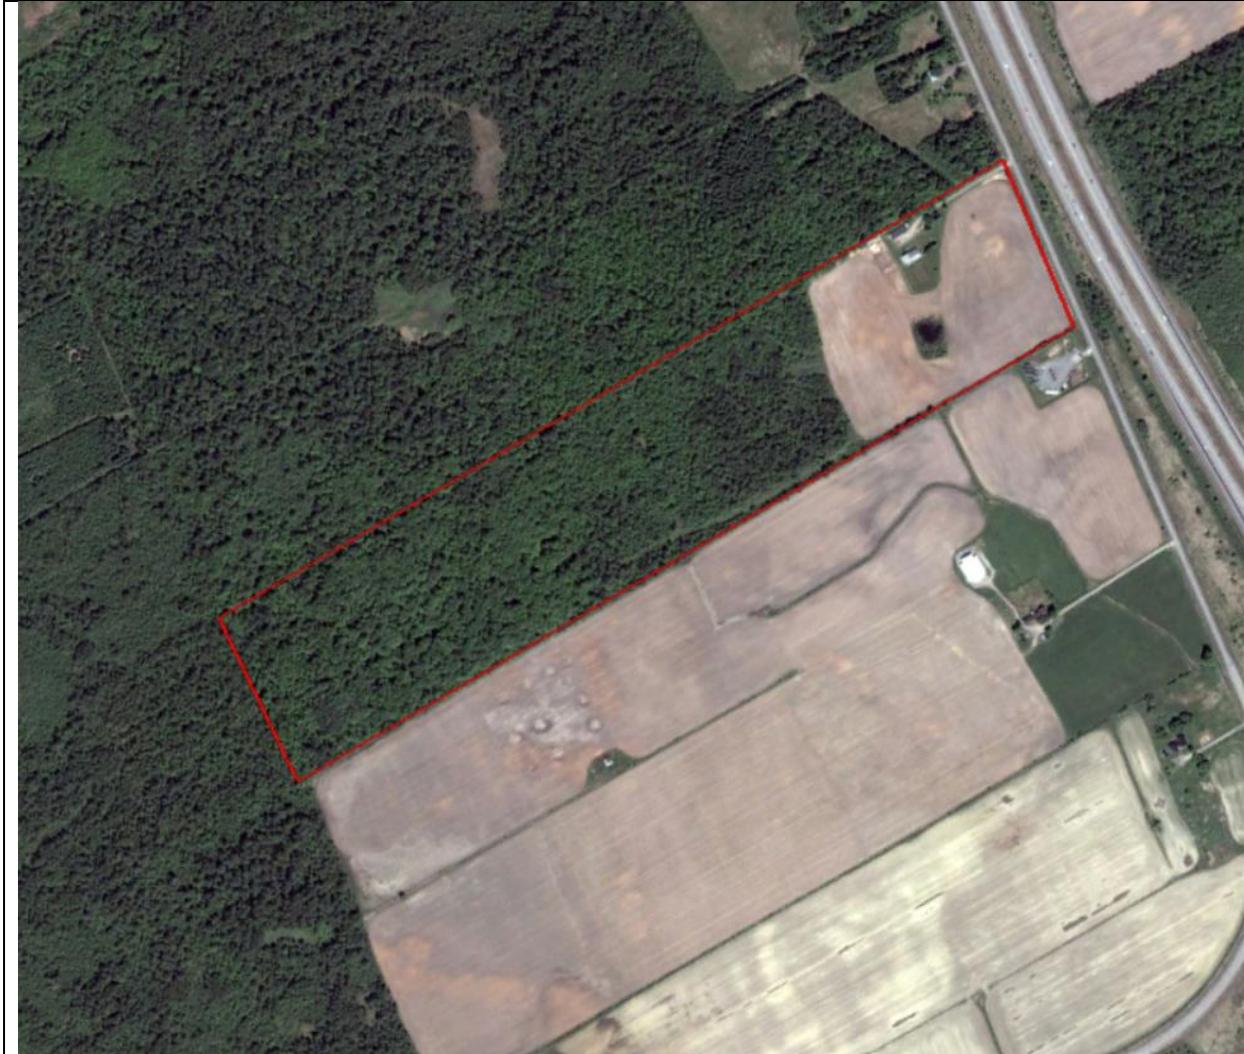
By 2012, a small wetland or pond feature is present along the tributary to the south. The constructed side banks of the Creek are no longer visible, and the channel condition appears to deteriorate. This may have resulted from a flooding event. By 2016, the Creek shows signs of widening, and an additional pond feature emerges along the tributary downstream of the project site. Tree cover within the subject property remains consistent.

**Location:** Ottawa, ON  
**Year:** 2012  
**Scale:** 1:14,000  
**Source:** Google Earth Pro  
**Red Boundary:** Site Limits

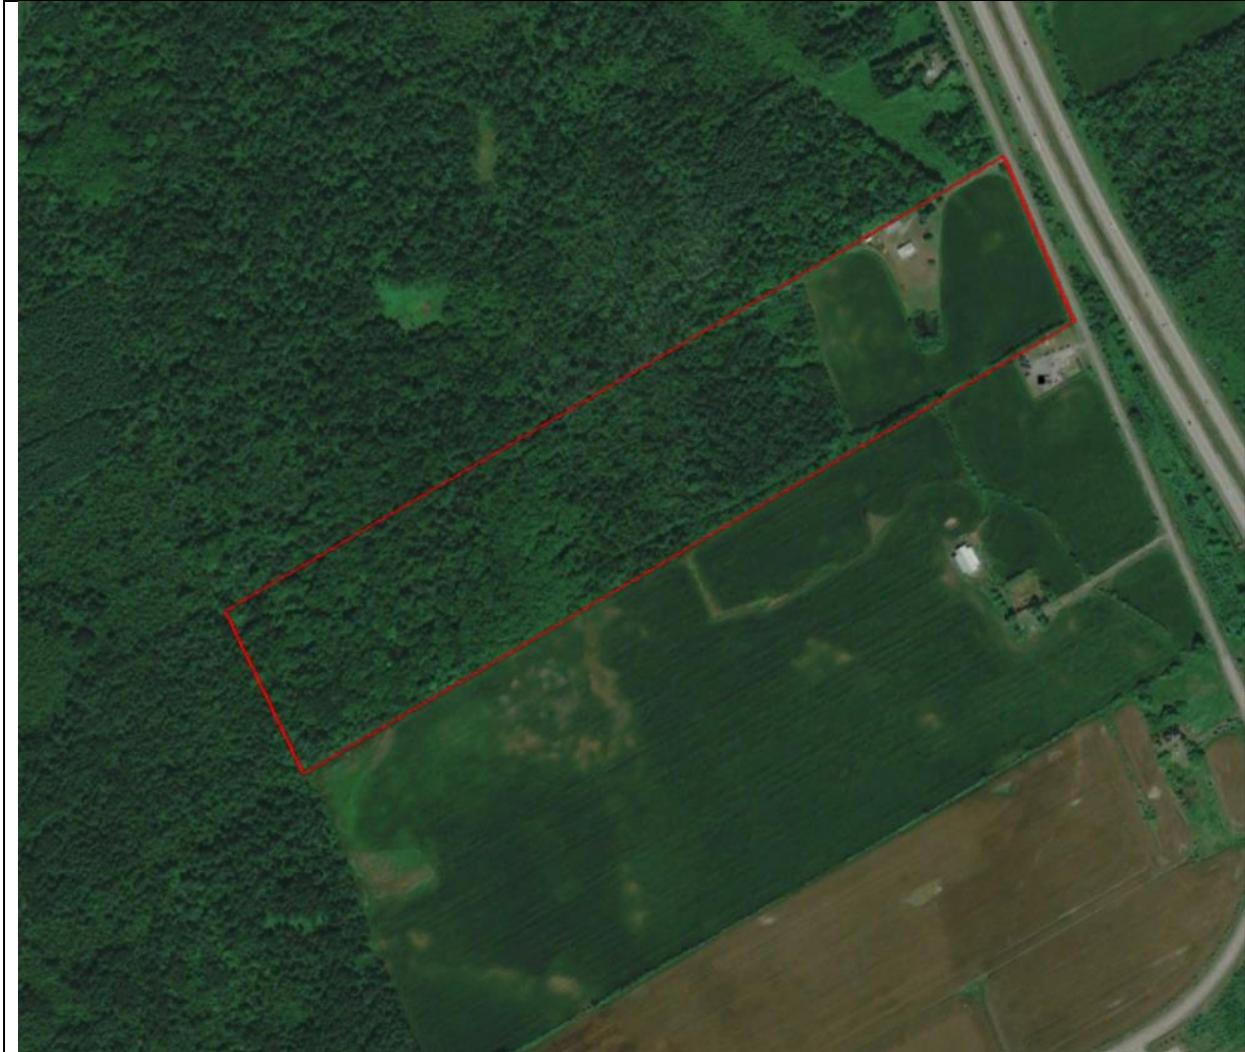
By 2020, the constructed banks are no longer visible, and the condition of the Creek continues to degrade through to 2024. In general, the Creek within the Project site follows a straight alignment; however, no visible changes to the planform of the tributary are observable in all aerial imagery due to tree cover.

**Location:** Ottawa, ON  
**Year:** 2020  
**Scale:** 1:14,000  
**Source:** Google Earth Pro  
**Red Boundary:** Site Limits

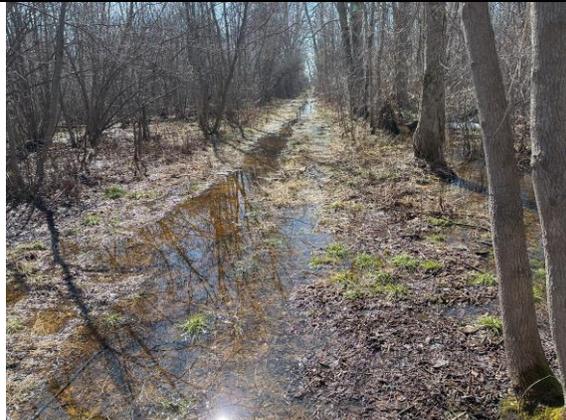
At the north boundary of the Project site, along the property line shared with the adjacent parcel, stagnant water was observed accumulating in a depressed corridor perpendicular to the main Creek alignment as shown in Photo 2 (Appendix B) from location S1. The presence of standing water outside the defined channel zone may also suggest the existence of secondary flow paths or backwater effects during wet periods, although no defined channel is visible in this area.

**Photo 2:** View looking northeast at the north site boundary (perpendicular to the creek), showing stagnant water on April 7, 2025.

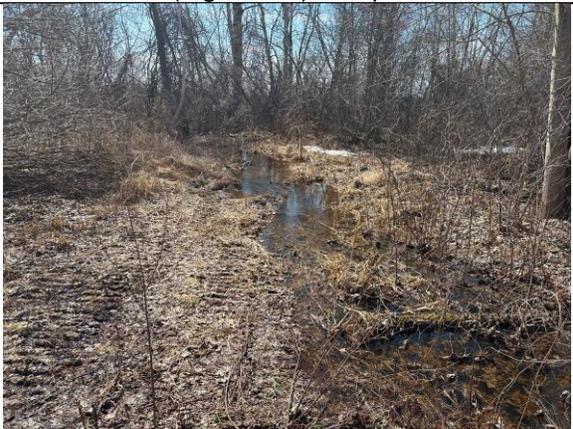
In several locations, including the area shown at location S8 (Photo 16 in Appendix B), evidence of localized channel adjustment and planform variability was observed. The Creek exhibits minor sinuosity, with lateral deflections of the low-flow channel that suggest active, albeit limited, fluvial processes. These deviations in flow alignment are likely the result of small-scale bank erosion and scour occurring along the outer margins of emerging meander features. While the degree of meandering is minimal due to the confined nature of the corridor and limited stream power, these features may represent the early development of a meander belt within the system.

**Photo 16:** View looking southeast (downstream) at location S8 (Figure 3-1) (minor sinuosity) on April 7, 2025.
